FACILITY COMPLIANCE AUDIT REPORT

Division of Waste Management Solid Waste Section

Date of Audit: 06/04/09

Henson's, Inc. Mulch & More
116 Pond Road
Asheville, NC 28806

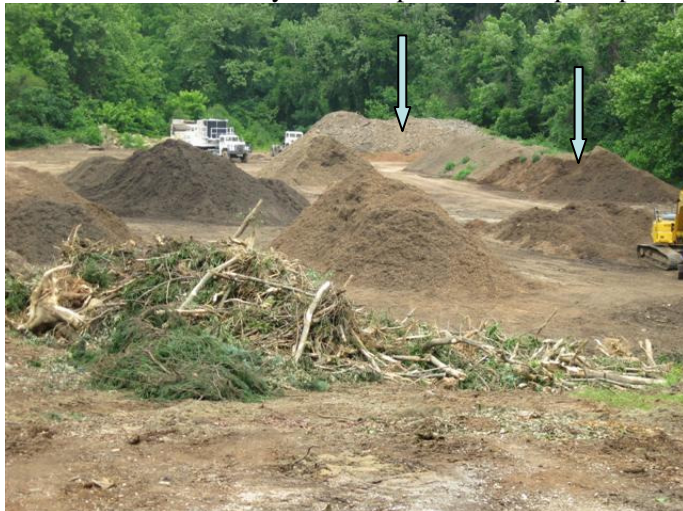
areas and Hominy Creek. Additionally, the permit states in Section 2.3.5 that “a minimum 50 foot buffer between the stream and any processing and storage area will be maintained.” **Please ensure that the silt fencing is in place and that the buffer is maintained.** The arrows noted in the photo below indicate several waste piles along the Hominy Creek side of the site which, according to your figure, appear to be located within the 100 year flood plain and are perhaps within your 50’ minimum buffer as well.

06/04/09

Additionally, in “Exhibit D” of your permit application the Buncombe County Development Permit states, under the Commercial Mulch Storage heading, “Note: No wood waste/mulch to be stored in the floodway.” **Please review your 100 year flood plain limits and comply with your development permit requirement.**
